PENNSYLVANIA  
GALLO DAM

NDS I.D. No. PA - 00233  
PENNDER I.D. No. 56 - 91

PHASE I INSPECTION REPORT  
NATIONAL DAM INSPECTION PROGRAM

SEPTEMBER 1979

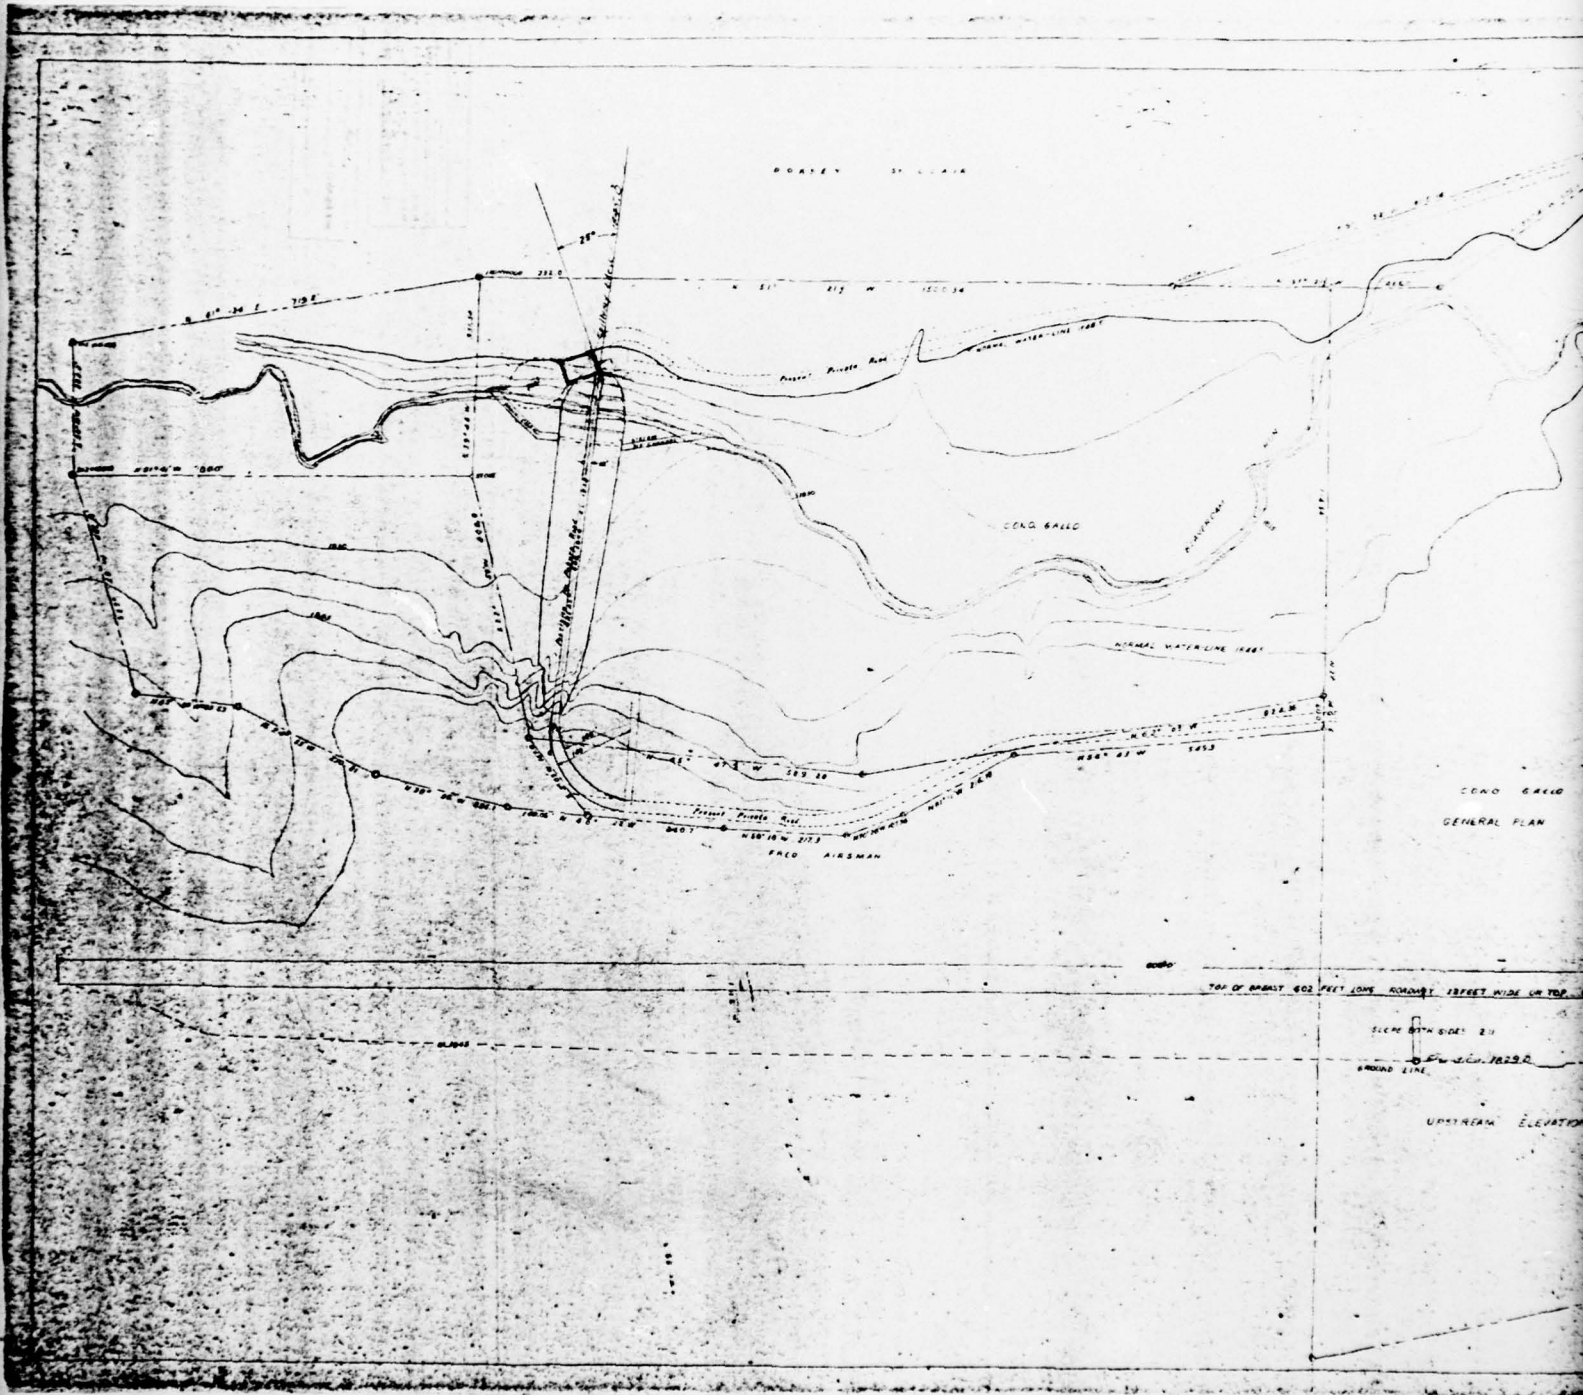
FIGURE 1 - GALLO DAM  
GENERAL PLAN  
FIELD INSPECTION NOTES

b. Embankment. Observations made during the visual inspection indicate the embankment to be in fair condition. Deficiencies include a heavily overgrown and brush-strewn downstream face, an uneven downstream slope with erosion ditches at several locations (See Figure 1), and swamp-like conditions immediately downstream of the embankment toe.

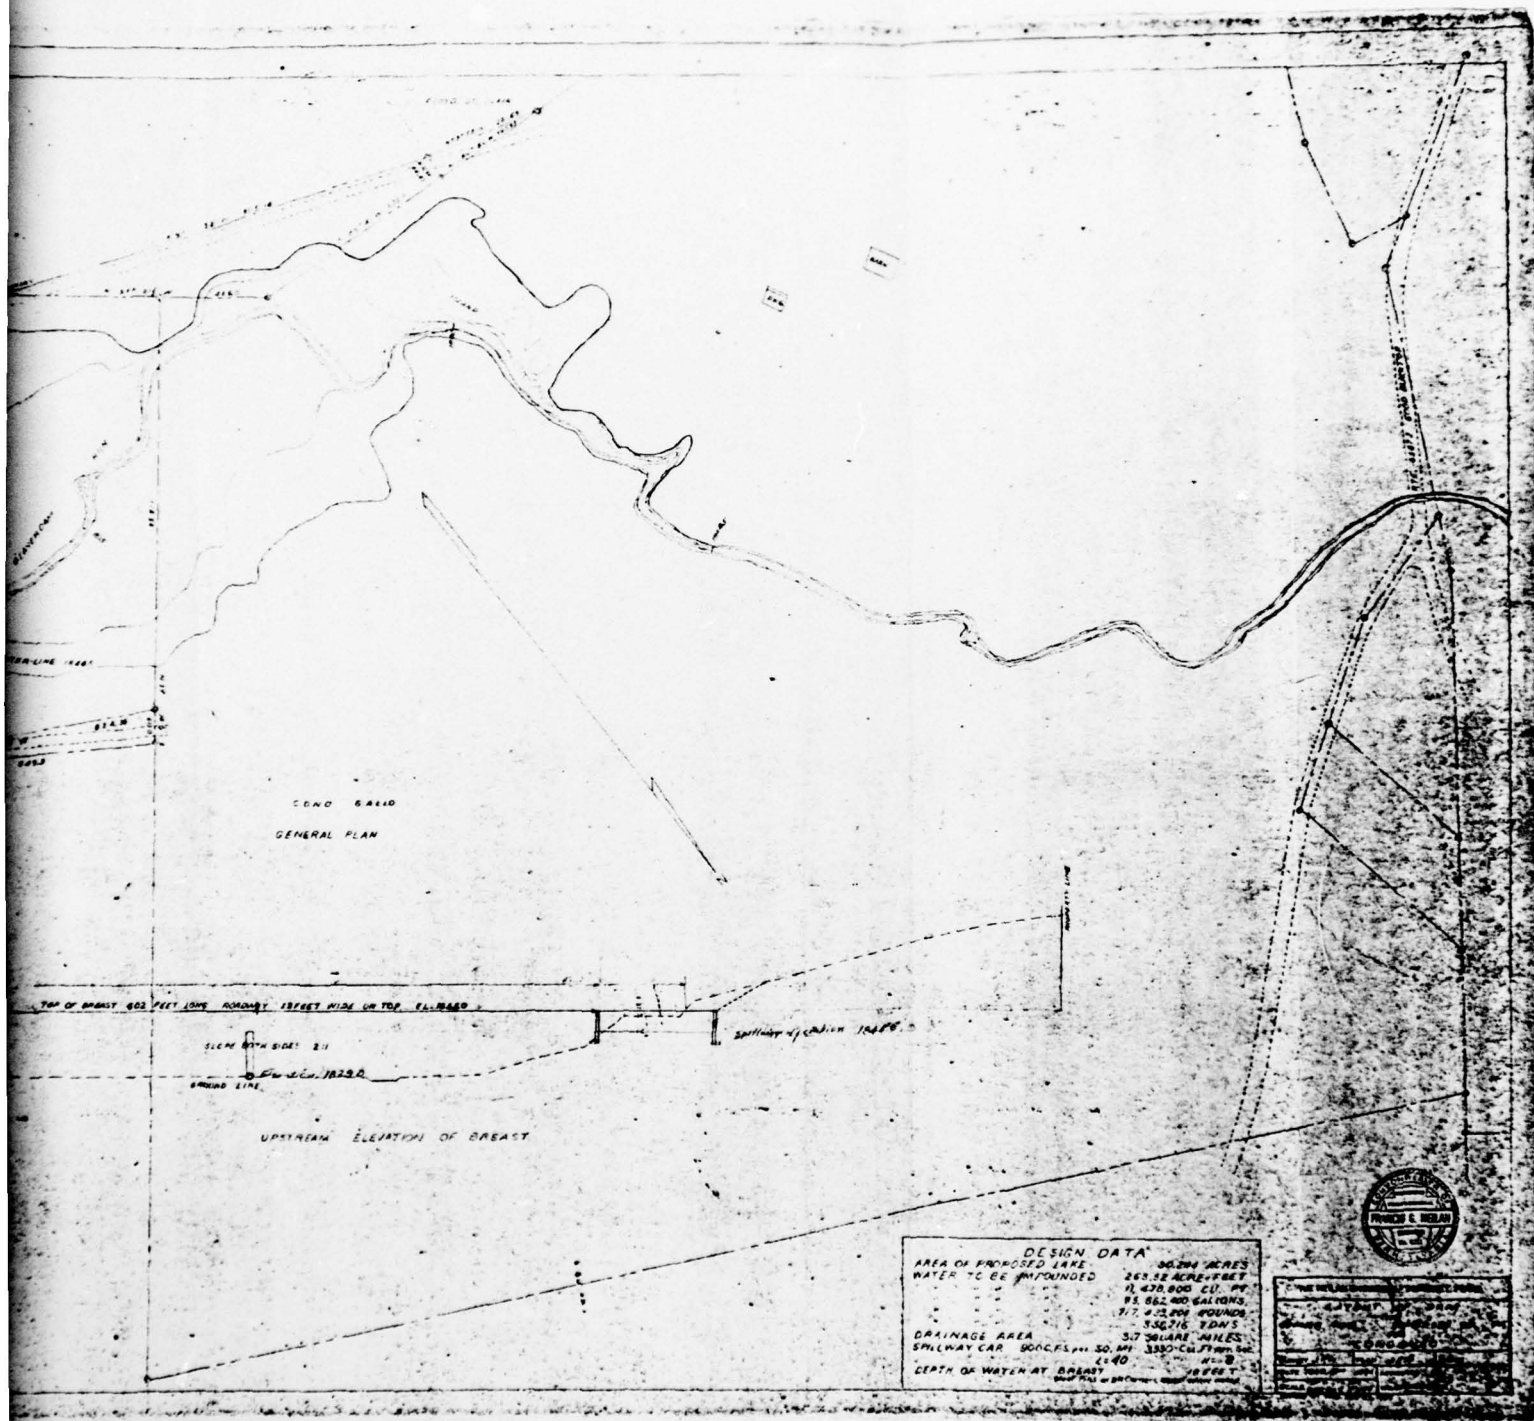
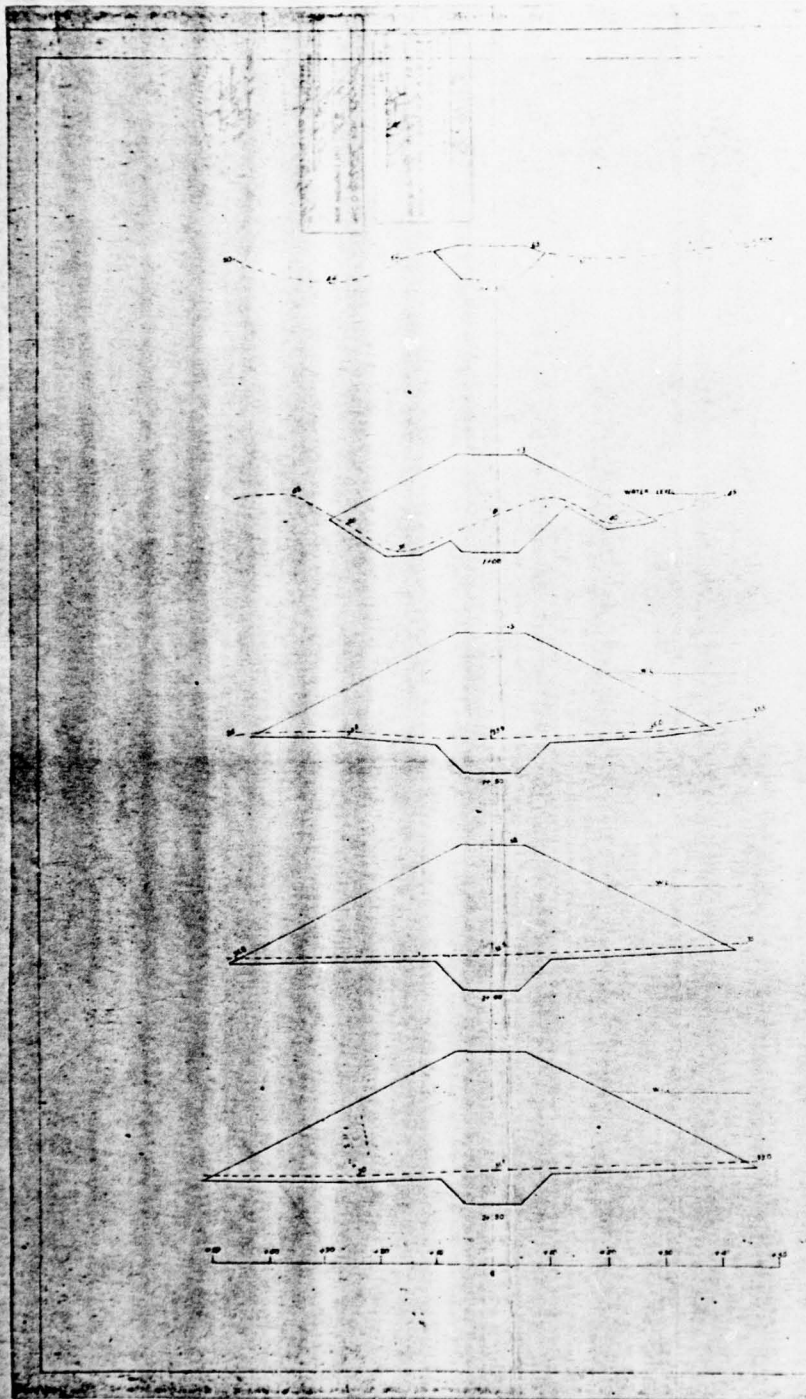
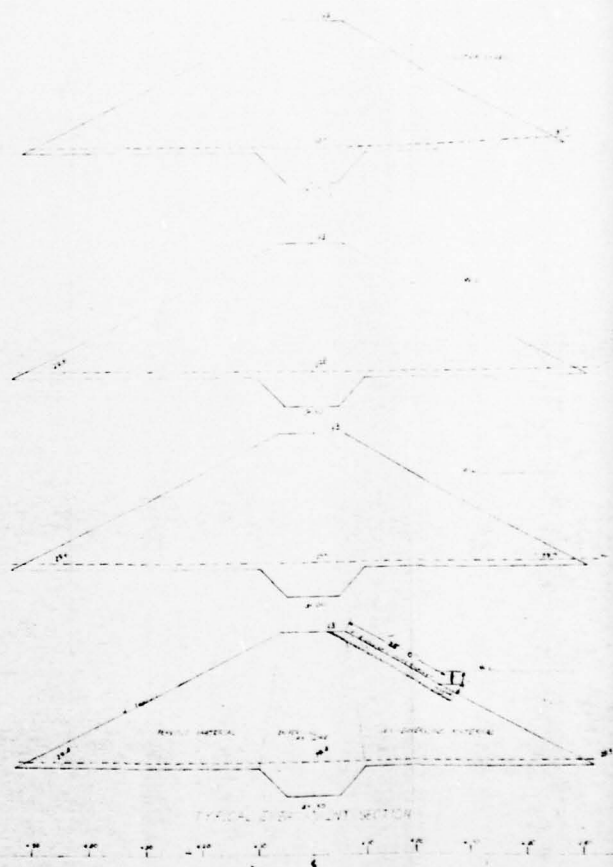
FIGURE 2

1. Change in the inclination of the spillway with respect to the dam axis as shown on design drawing (Figure 2).
2. Deletion of the concrete riser which was to function as the primary spillway.

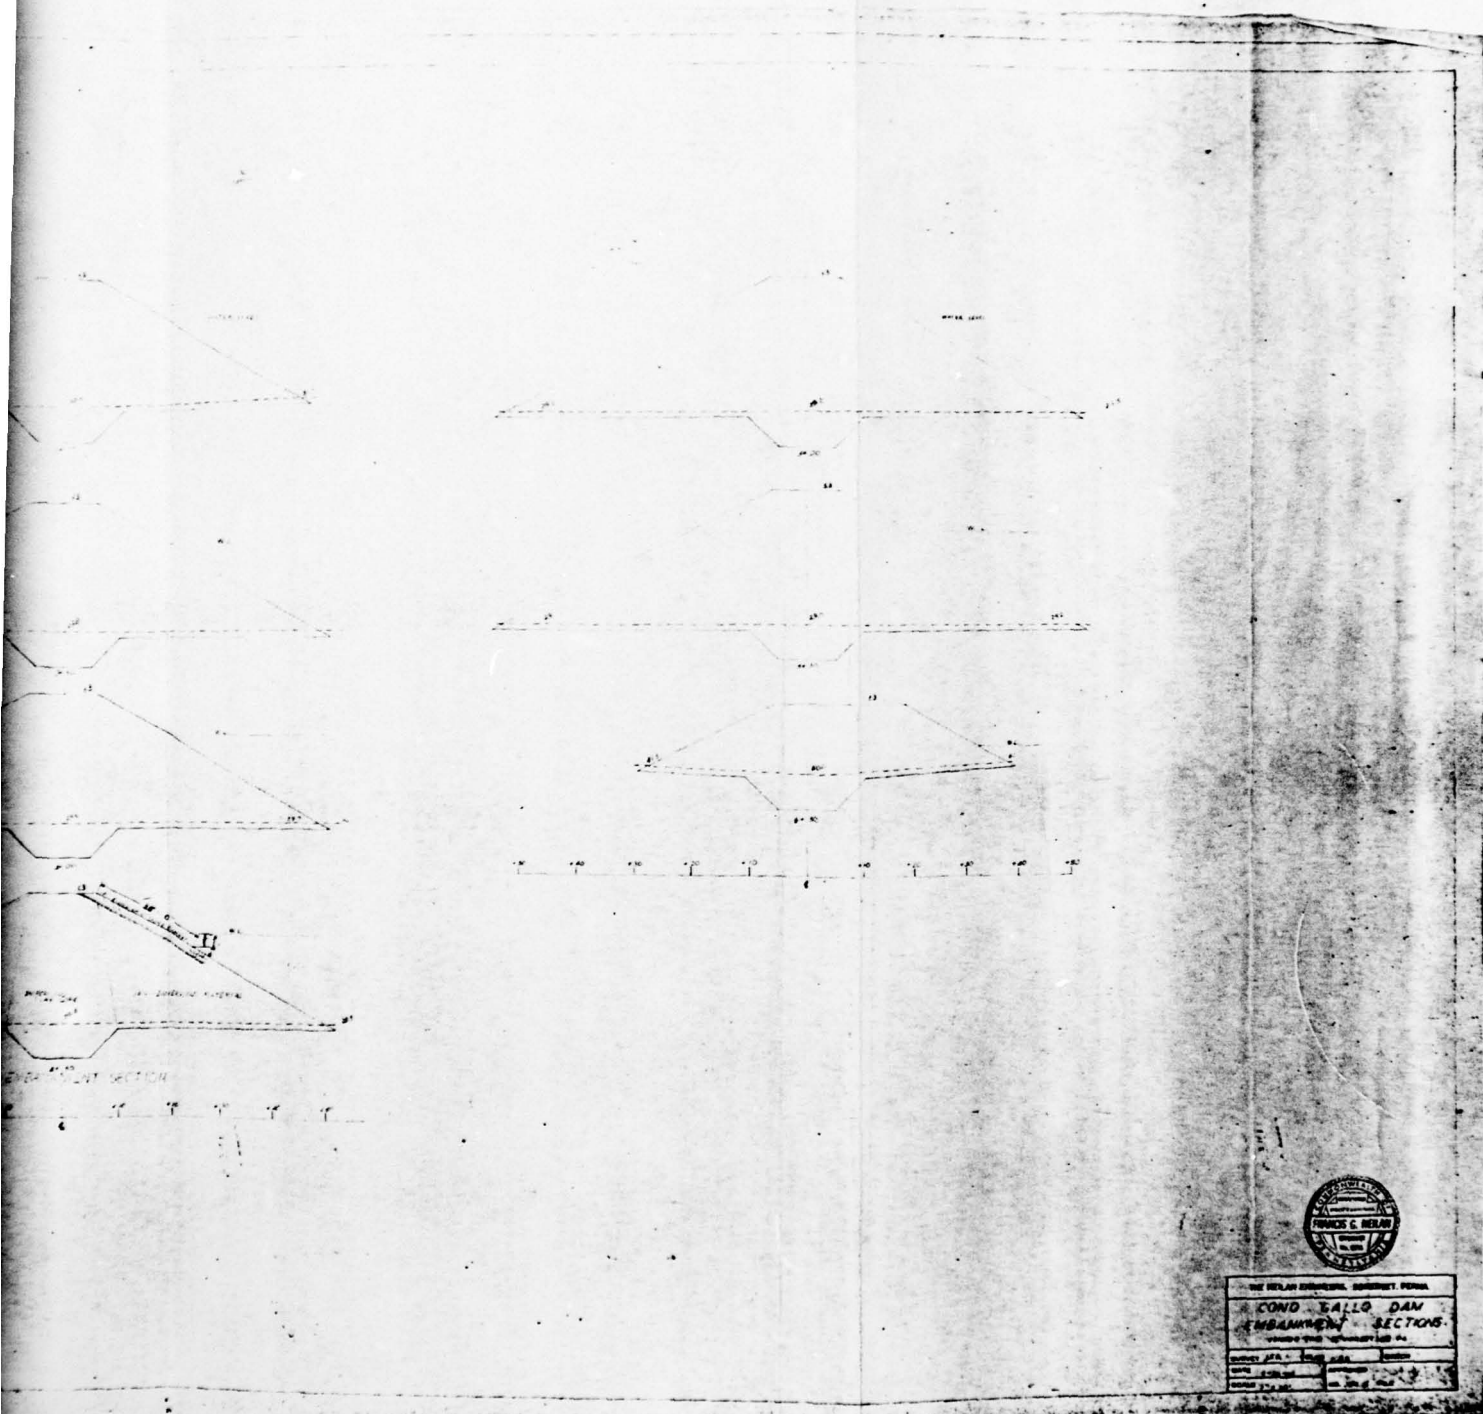
FIGURE 3

a. Dam and Appurtenances. Gallo Dam is a 29-foot high earth embankment approximately 690 feet long (including spillway). The embankment is reportedly comprised of 3 sections which include an impervious core, a semi-pervious upstream section and a pervious downstream section. (see Figure 3).

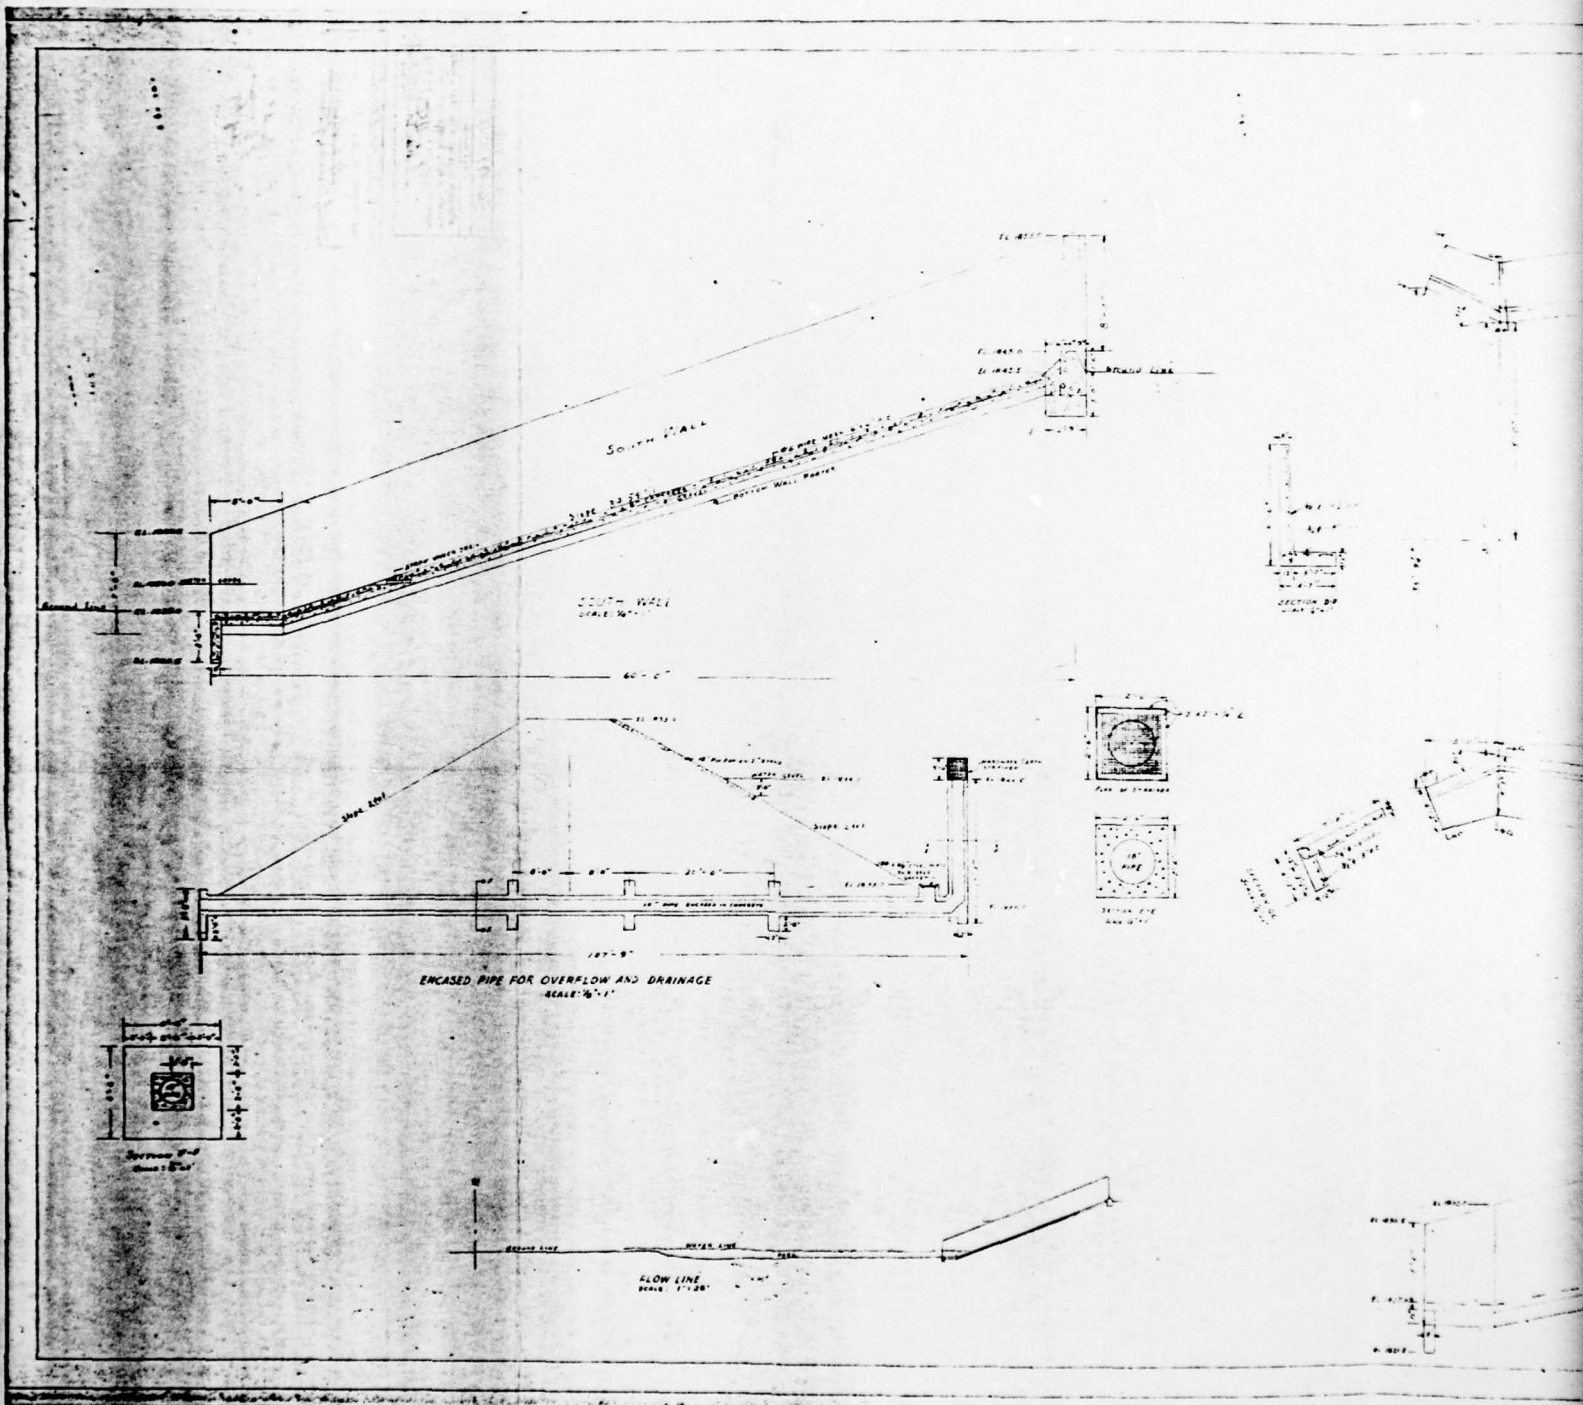
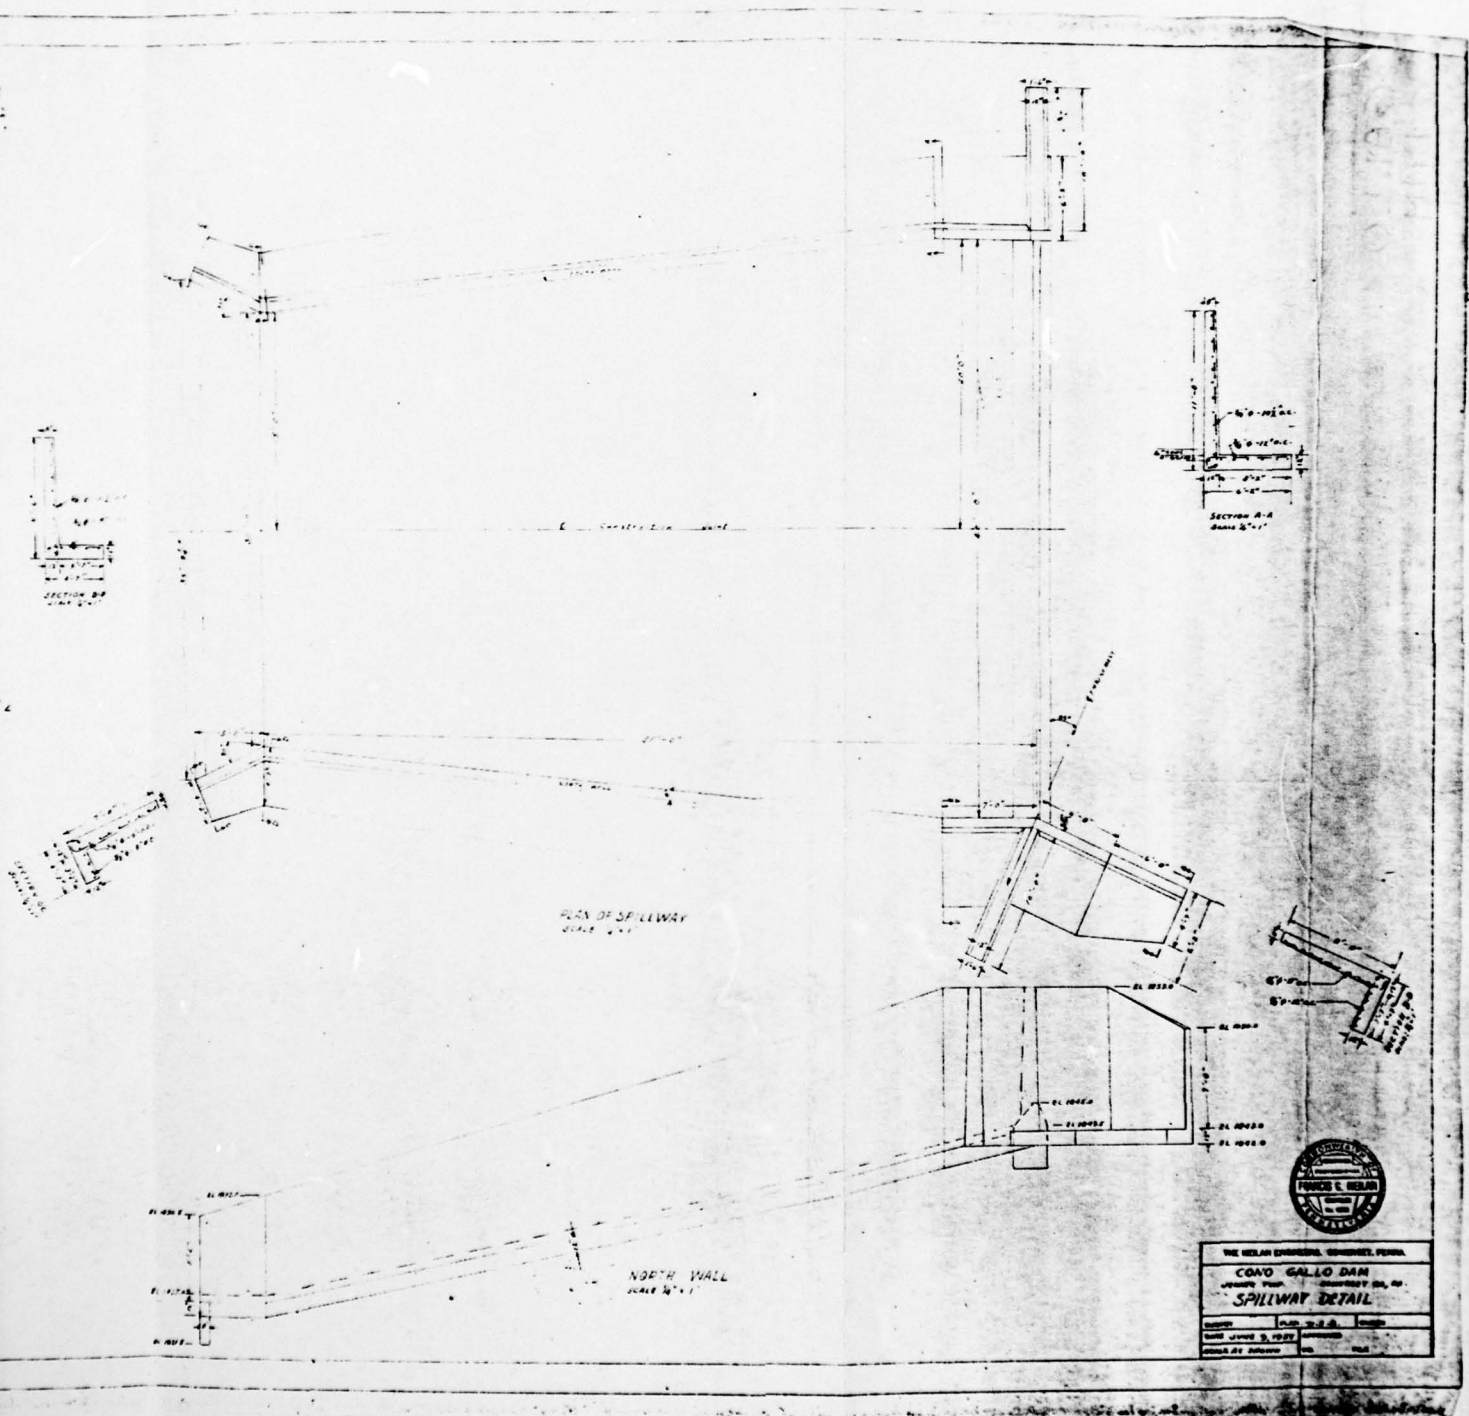
FIGURE 4

2. Outlet Works. The low level outlet works at Gallo Dam consists of an 18-inch diameter steel pipe encased in concrete. The dam owner reports that a concrete lid covers the small riser on the upstream end of the pipe as shown on Figure 4. A galvanized steel cable is attached to the lid and to the dam crest by an embedded metal anchor. A 16-inch diameter steel pipe siphon was added to the facility in 1973 to afford the ability to lower the reservoir to about 6 feet below normal pool, if necessary. The siphon was operated in the presence of the inspection team, but the low level outlet has apparently never been utilized. According to the owner, a diver replaced the steel cable lid attachment in 1978.
